## General Condition Survey

St. Louis Port Authority

## Municipal River Terminal

Report No. W0312-1398

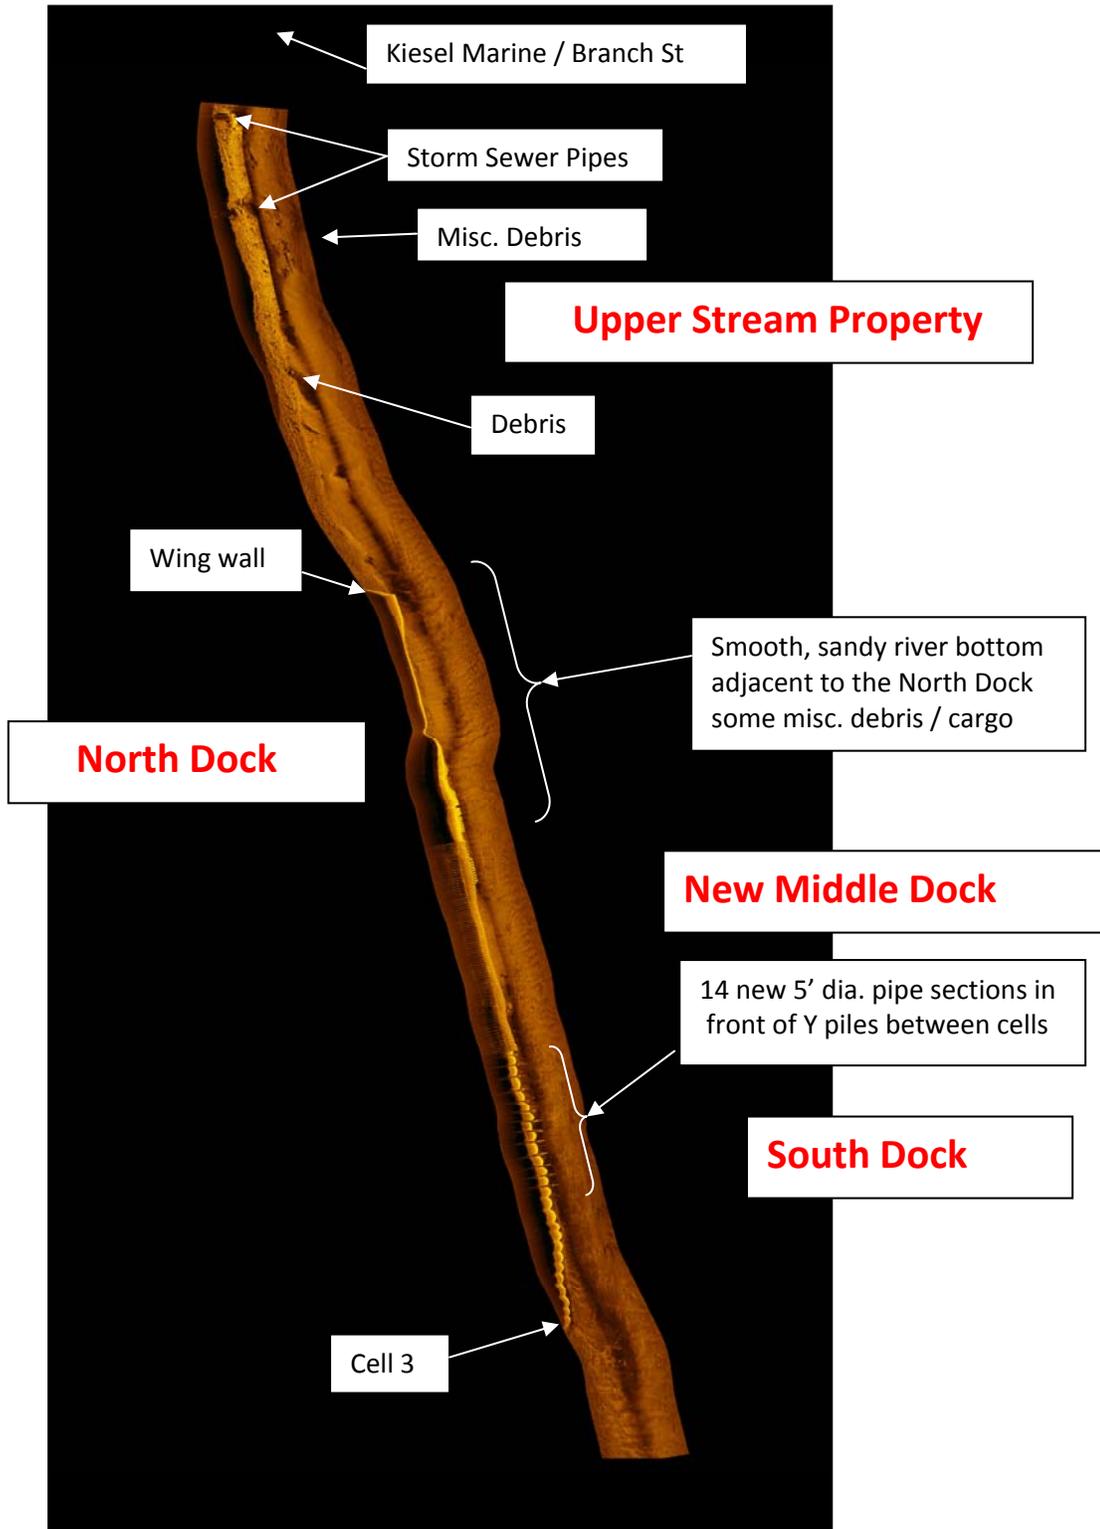
River Diving and Salvage Side Scan Sonar Image

The side scan sonar survey revealed that the upper portions of the site property river bank have been well stabilized with rip rap and construction debris. The river bank armament stone extend to a typical uniform 'toe'. Extending out from the stone rip rap, the river bottom is typically smooth sandy bottom. A few misc. areas of debris were noted which, if removed, would allow a safe barge fleet to operate in the area.

In general the area was found to be in very good order and generally free of debris. It should be noted that the area adjacent to the north dock had been recently dredged with mechanical dredge equipment, by Gateway Dredging, to return the area to sufficient water depths to accommodate loaded barges. It was reported that 30,000 tons of river sand and sediment had been removed. As a matter of record, it was also reported that Gateway Dredging and St. Louis Bridge Co. had removed a total of 800 tons of misc. spilled cargo and debris from along the south dock and along the 'middle dock' areas as part of the preparation work to drive sheet pile for the large rehabilitation work.

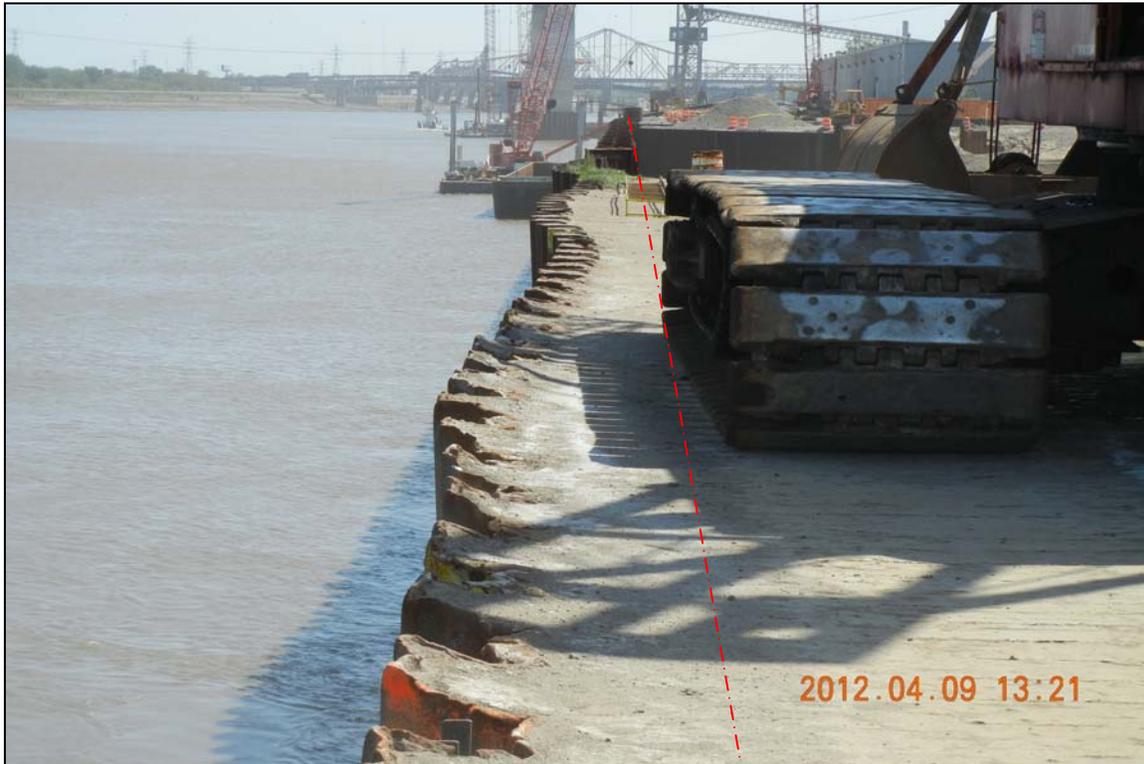
**Alignment of the North Dock referenced from the new Middle Dock Beams**

The top of the North Dock wall waves from the shore-side, into alignment, and to the river-side throughout its 664-foot length. For example, the up-stream limit of the dock wall (Corner # 30) is approximately 5.75-inches shore-side of the Middle Dock face; at numerous locations including Pair # 106 the wall is in-line with the Middle Dock wall, at Pairs # 129 thru #145 the wall is shore-side approximately 10.0-inches; and at Pairs # 173 to # 176 the wall goes to the opposite direction at 10.0 to 12.0-inches river-side. The extreme case is at the southern end of the North Dock where Pairs # 190 and 191 are 12.87-inches and 17.86-inches river-side respectively, but should be brought back into alignment during its re-construction.

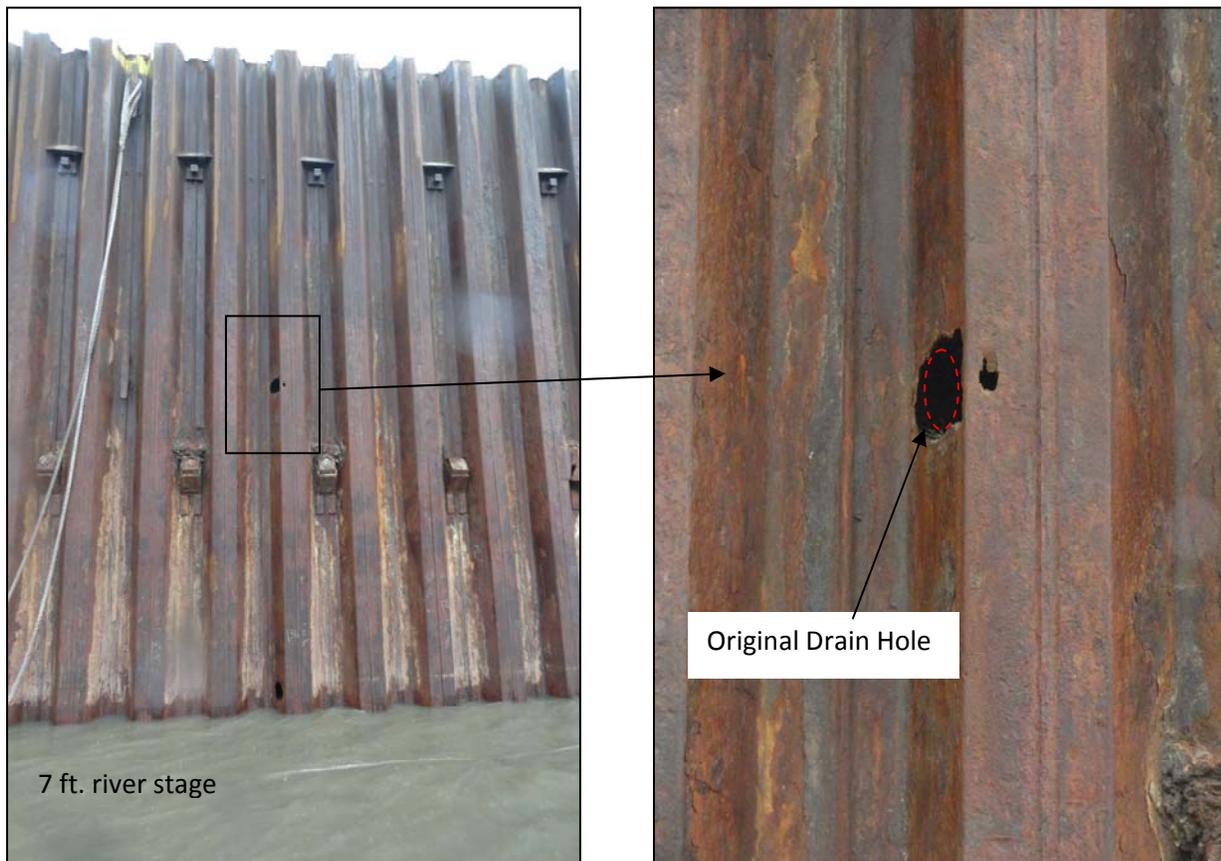
The sheet pile adjacent to the hydraulic drain port on Sheet Pile Pair 130 was found to be corroded completely thru the  $.600''$  face of the pile. This corrosion rate would be approximately  $.023''$  per year. This condition will likely continue. The loss section modulus of the sheet pile pair will ultimately create a localized failure.

**View at Sheet Pile pair No. 130 which displays extensive corrosion to the PZ-35 sheet pile. The corrosion has extended thru  $.600''$  of steel at the upper drain hole near Elv. 384**

**This area of sheet pile should be closely monitored and considered for repair.**

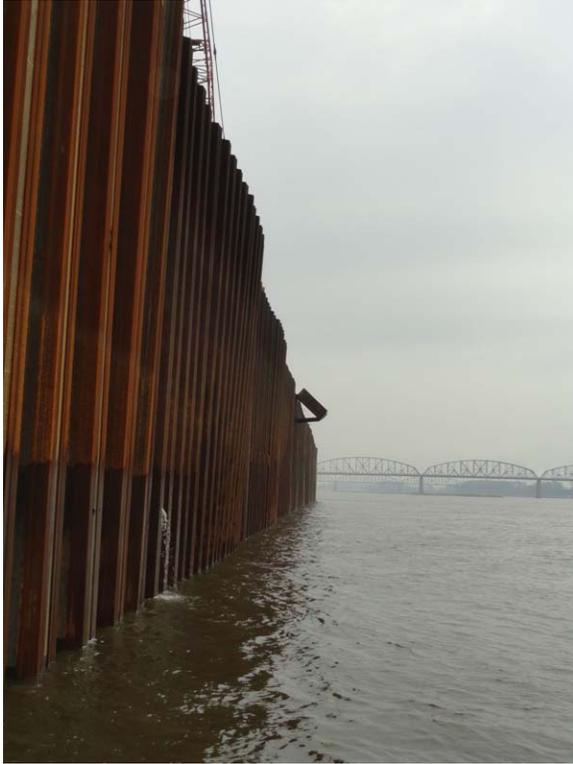
WALL ALIGNMENT (LOOKING UP-STREAM)

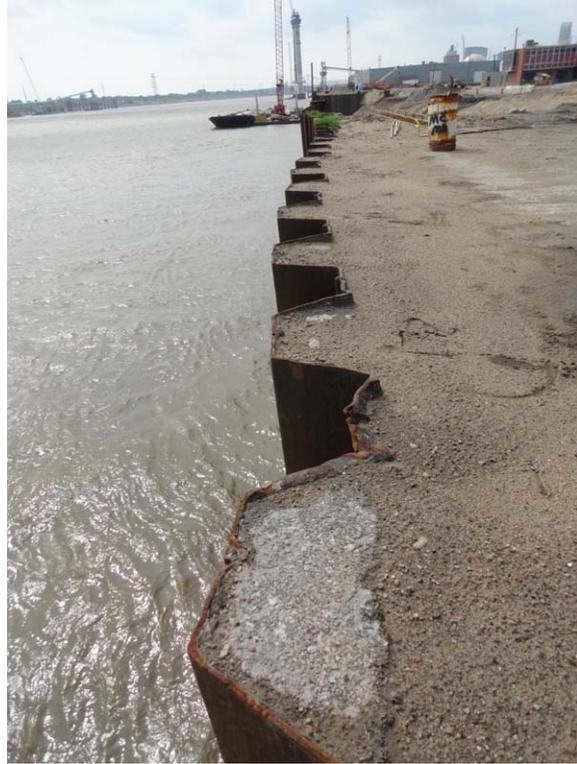
WALL ALIGNMENT (PAIR # 170)

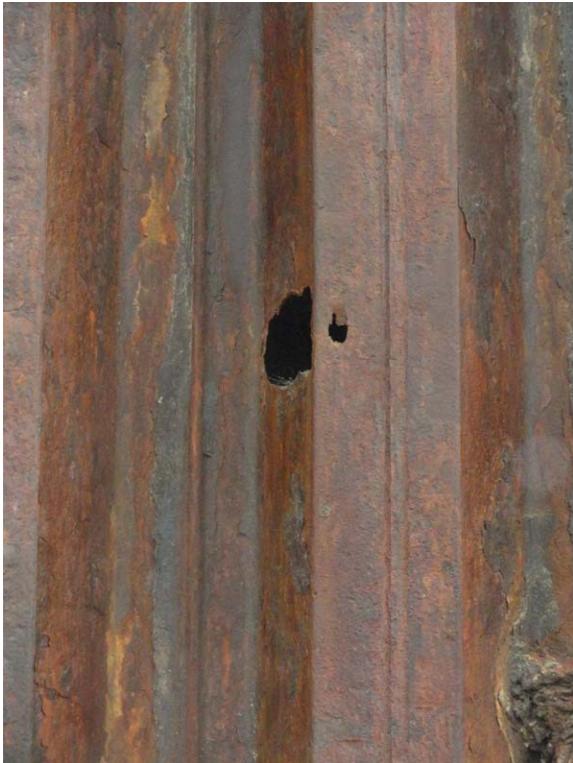
DRAIN CORROSION (PAIR # 130)

Sheet pile hydrostatic drain discharge areas repair and reinforcement

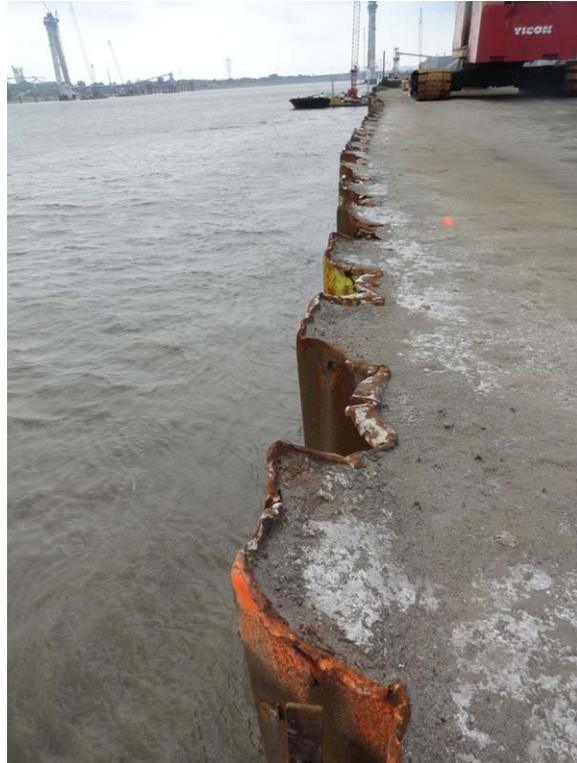
The tops of the sheet piles have been distorted and rolled outward along the majority of the dock face. The sheet pile interlock has been forced apart as the sheet pile tops were deformed, presumably by contact with the crane tracks during cargo unloading operations.

At this juncture the pile top deformations appear to be confined to the upper 4 to 6-inches of sheet pile. See the photographs for more detail. It would appear that the damage conditions have 'stabilized'. Further contact between the distorted sheet tops and the crane tracks is now not likely to cause further deformation to the lower portions of the sheeting.

TOP OF SHEETING DAMAGE (PAIR # 59.5 THRU 99.5)

As previously described above, the upper portions of the sheet pile were crushed and deformed from the top of the sheet pile pairs extending downward from 4 to 6-inches. The deformed sheet piles were rolled outward and flared. The sheet pile interlocks have been forced apart to conform to the deformations. These conditions were noted along a 150-foot length of the dock wall from Pair # 59.5 to Pair # 99.5.

Sheet pile top deformations. This condition should be monitored.

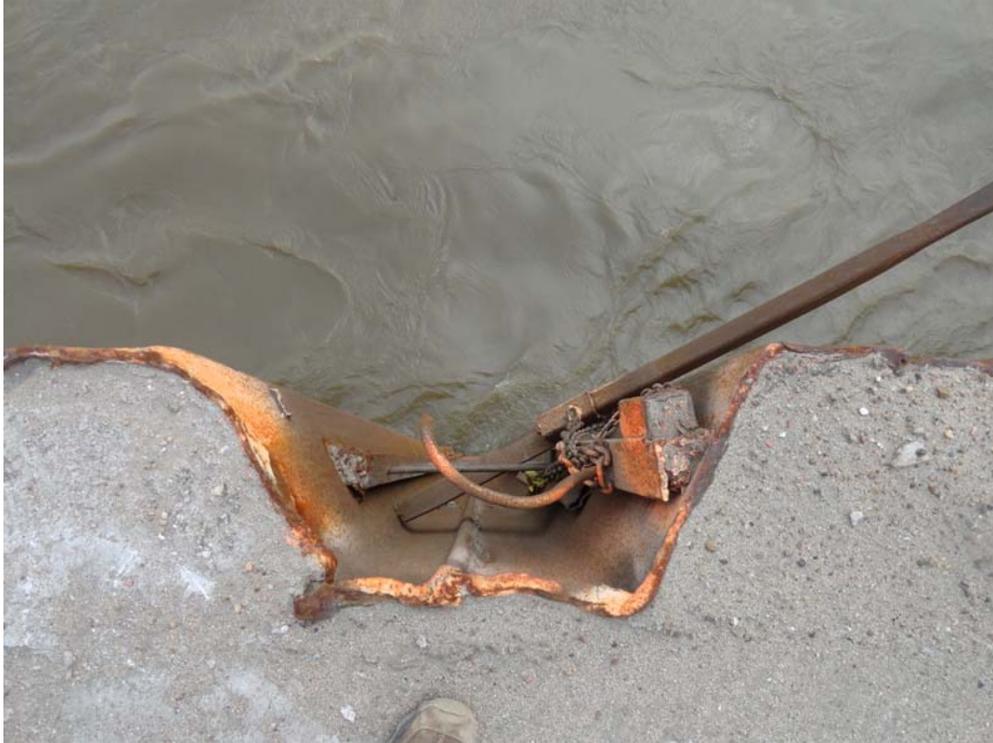
LADDER DAMAGE (PAIR # 110.5)

Pair # 110.5 –

- Top and bottom rungs damaged.
- Bottom rail connection to sheet pile was loose.

Ladder repair and reinforcement

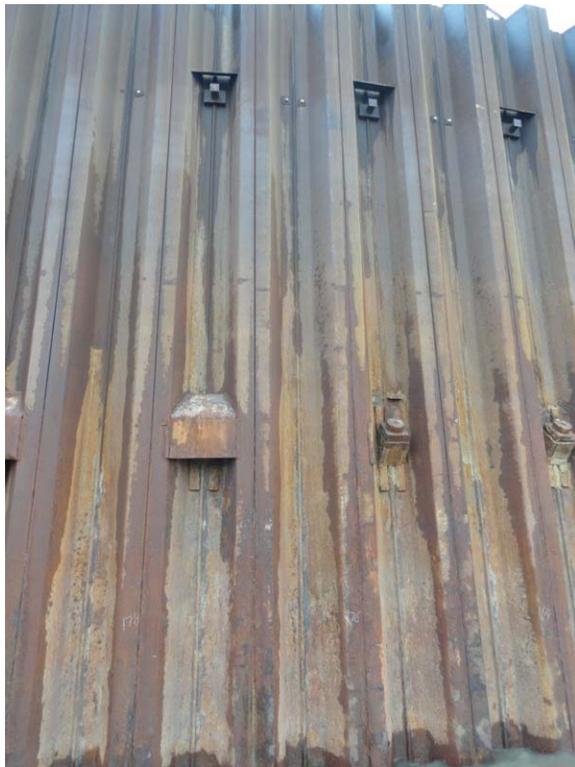
ROCK ANCHOR COVER PLATES - MISSING

The lower rock anchor tie backs appear to be in good order. Many of the “protection cover plates” have been damaged and / or torn off. This has been brought to the owner’s attention previously and no actions have been taken to reinstate the protection.

Rock Anchor cover / protection plate repairs.

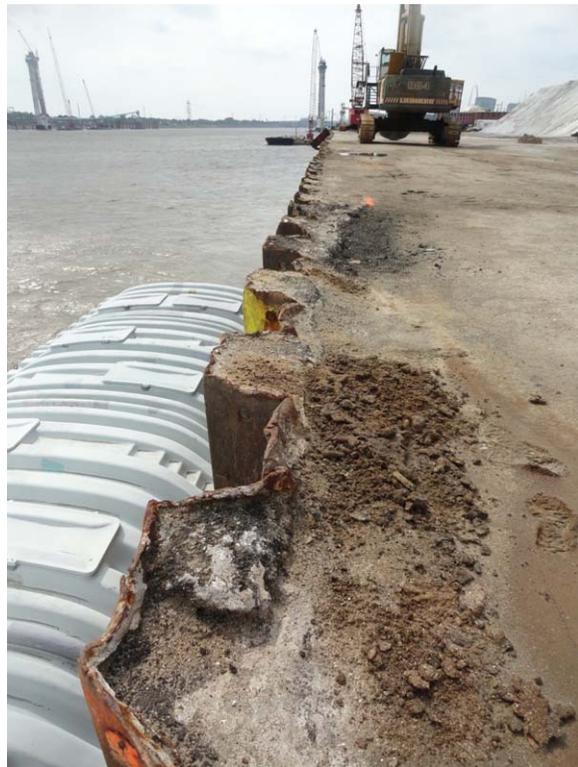
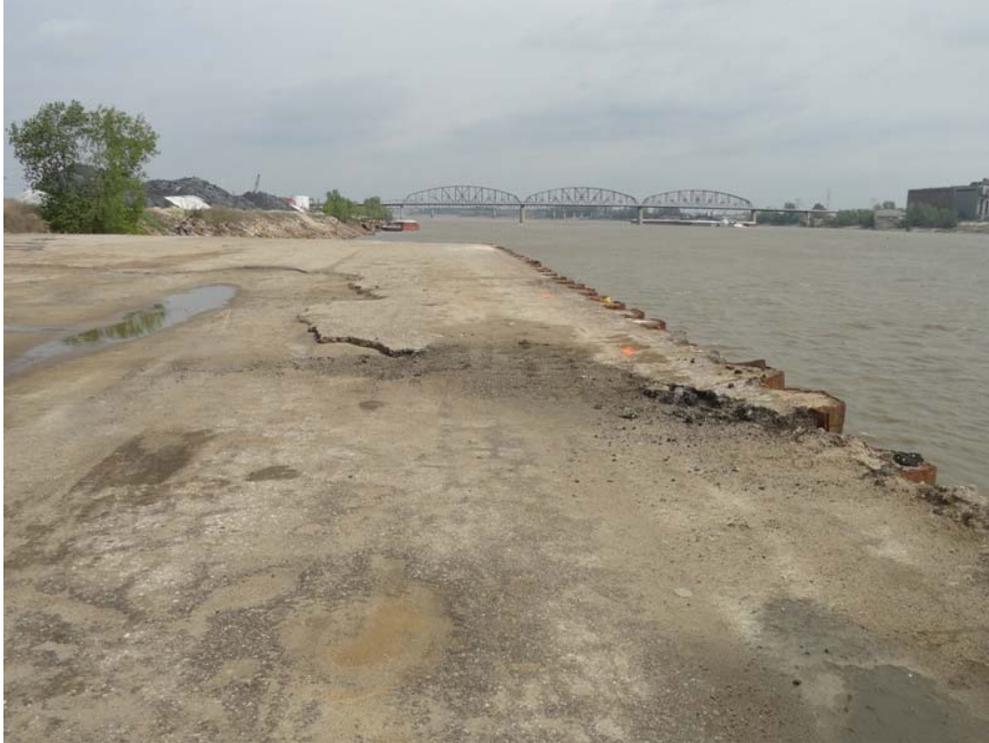
TYPICAL ASPHALT ADAMAGE (PAIR # 59.5 THRU # 77.0)

ASPHALT DAMAGE (PAIR # 59.5 THRU # 77.0)

The ‘crane platform’ areas appeared to be multiple courses of asphalt paving. Design documents indicated a thickness of 2-feet and a width of approximately 40-feet. An area of ‘wear course’ asphalt directly behind the dock wall has been damaged and is in need of repair. The extent of the damage is approximately 65-feet long at the dock wall, (Pairs 59.5 to 77.0) and continues at a diagonal direction toward the north, approximately 50-feet, and away from the dock face to a total width of approximately 30-feet. A minimum of 4-inches of thickness has been damaged and missing, and could be as much as 8-inches in some areas.

Asphalt repair
